REPORT NO. 96-46

2.75-INCH, HYDRA 70, PA151, ROCKET PALLET FIRST ARTICLE TESTING (FAT)

U.S. Army Armament Research, Development and Engineering Center

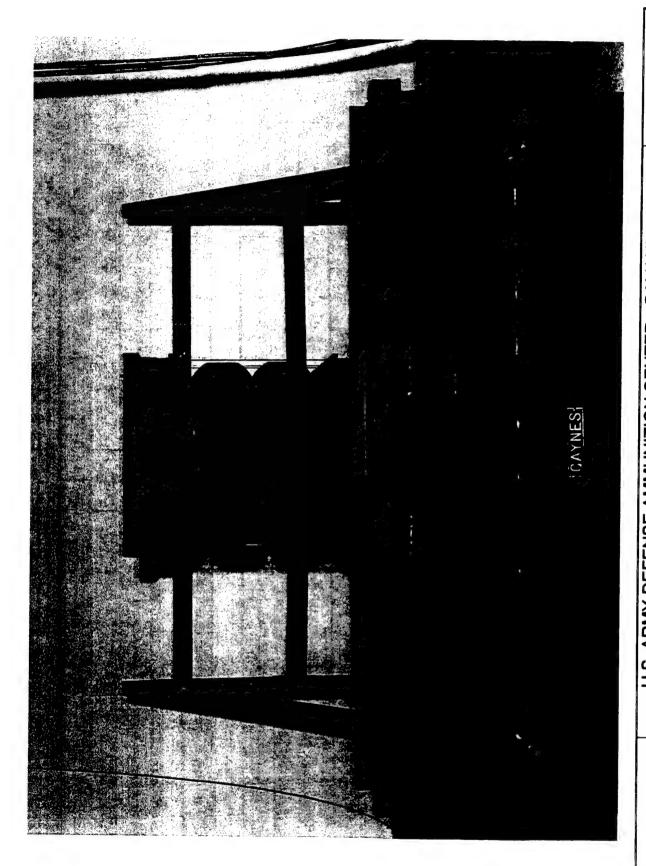
- 1. Compression Test. The test pallet was compressed with a load force of 8,985 pounds for 60 minutes. No damage was noted as a result of this test.
- 2. Repetitive Shock Test. The test pallet was vibrated 90 minutes at 220 rpm in the longitudinal orientation and 90 minutes at 165 rpm in the lateral orientation. Upon completion of the longitudinal vibration, the pallet was elevated and inspected from the bottom side. Small cracks were noted to have formed in the pallet posts along the skid.

PHOTO NO. A0317-SCN-96-145-4300. This photograph shows the pallet on the shaker table in the U.S. ARMY DEFENSE AMMUNITION CENTER - SAVANNA, IL longitudinal orientation.

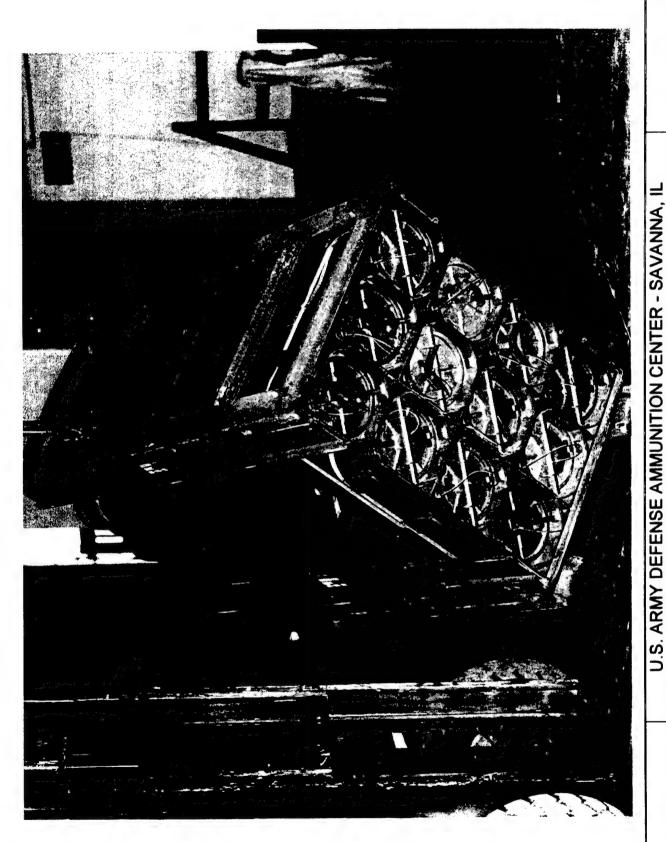
- 4. Sling Compatibility Test. The test pallet was lifted off of the ground using the toplift adapter by four points, three points, two diagonal points, two adjacent points, and one point. No shifting of the containers or permanent deformation of the top-lift was noted.

PHOTO NO. A0317-SCN-96-145-3523. This photograph shows the pallet being lifted by one point during the sling compatibility test.

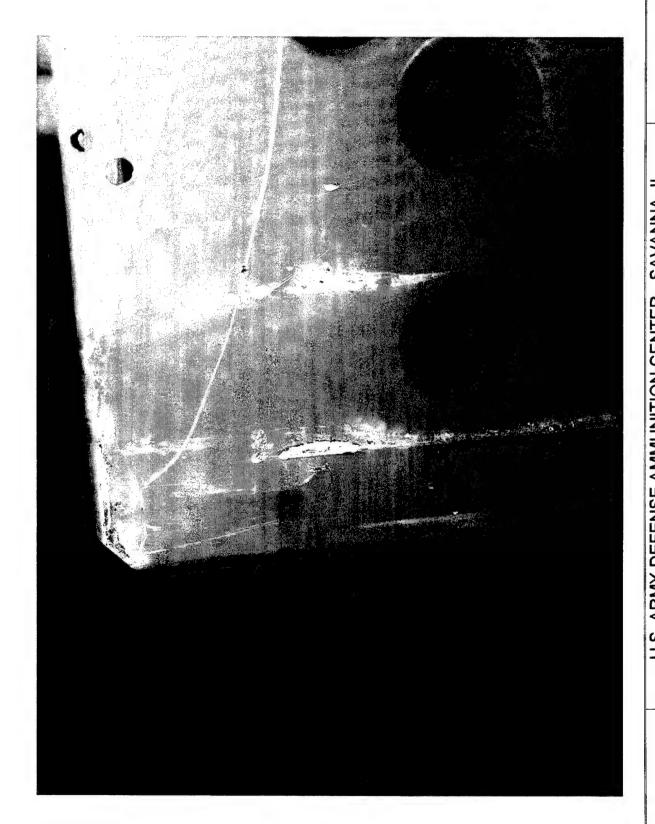
PHOTO NO. A0317-SCN-96-145-3543. This photograph shows additional damage that occurred during U.S. ARMY DEFENSE AMMUNITION CENTER - SAVANNA, IL MIL-STD-1660 testing.
